Manhole Inspection Summary

Manhole # S45II_037MH

Insp Date: **4/25/08 1:16 PM**

Location Address: **Wolf St**

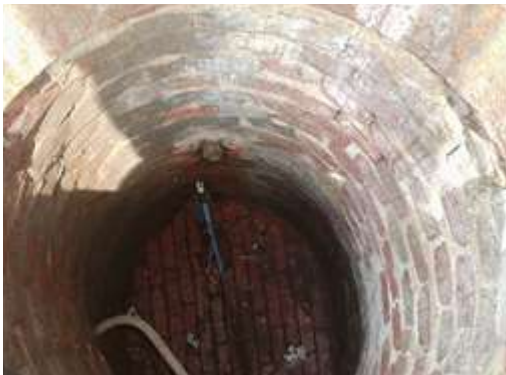
Defect 1

Condition: ☐ Sound ☐ Cracked ☐ Root Intrusion ☐ Loose Brick ☒ **Deteriorated**

Infiltration: ☐ None ☒ **Joint** ☐ Cracks ☒ **Mortar** ☐ Roots ☐ Wall

Deterioration

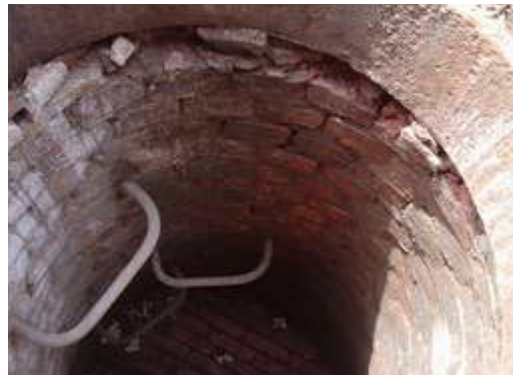
Defect 2

Frame Offset: **2** (in.) Condition: ☐ Sound ☐ Cracked ☒ **Leaks**

Frame Leaks

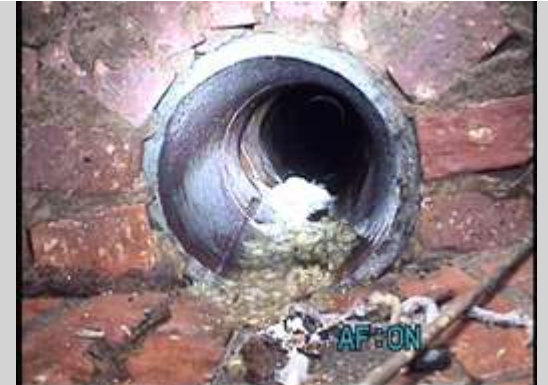
12 O'Clock Outflow

8 in. Circular Gravity Sewer
Pipe Out @ 12 O'Clock

Deposits: ☐ None ☐ Mud ☐ Sludge ☒ **Debris** ☐ Grease

Silt Depth: **1** (in.) Deposits Extent: **Light**
